**CANADIAN FORCES
FLIGHT SAFETY INVESTIGATION REPORT**

FINAL REPORT

FILE NUMBER: 1010-C-GGYS
DATE OF REPORT: 21 January 2002

AIRCRAFT TYPE: Bellanca Scout
DATE/TIME: 8 October 2000, 1345 Z
LOCATION: Alexandria Ontario
CATEGORY: B Category Air Accident

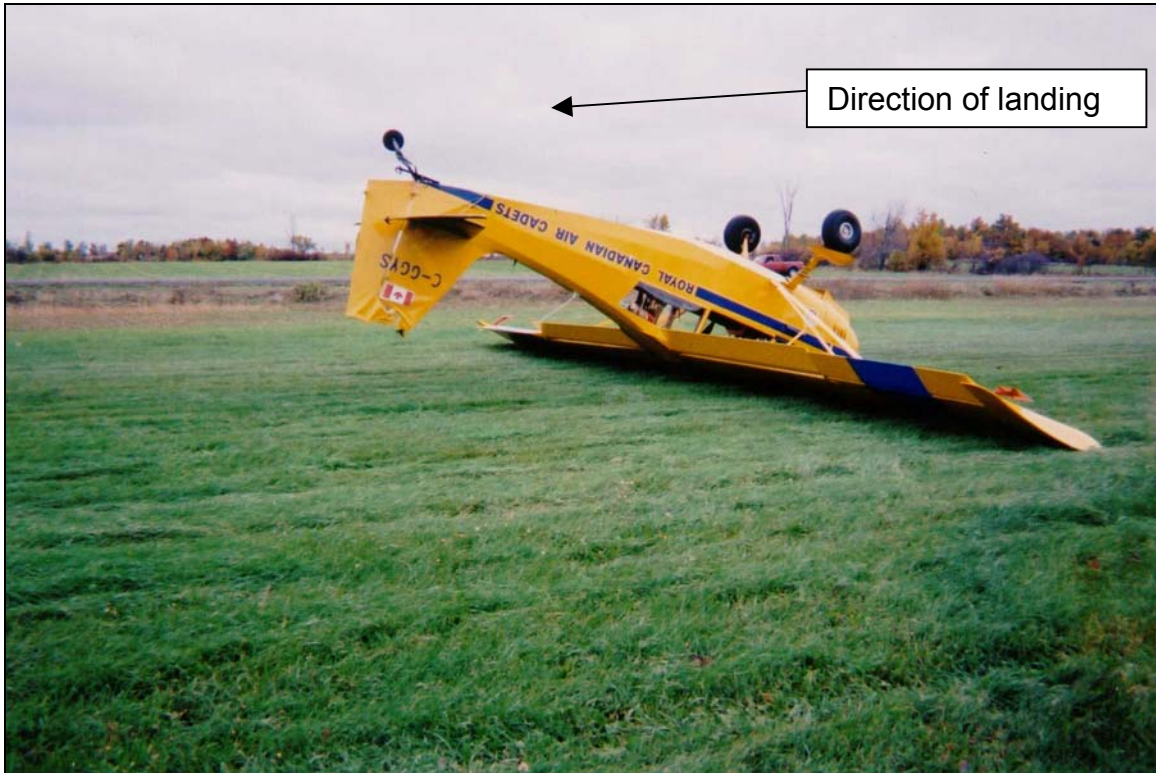
One tow aircraft and two gliders from the Quinte Gliding Centre (Mountainview) were deployed to the Alexandria municipal airport for the Thanksgiving long weekend. They were providing local Air Cadet squadrons glider familiarisation flights as mandated by the Air Cadet Gliding Program. The experienced pilot of the accident aircraft took off at approximately 0815 on the Sunday morning and carried out nine successful glider tows. On landing from his ninth tow, the pilot was observed to be slightly "longer" than previously. The aircraft landed slightly farther than normal and required heavier braking in order to stop at the launch point. The conventional landing gear equipped aircraft (tail-dragger) was almost at the end of its landing roll and travelling at no more than a brisk walking pace when the tail was observed to rise then return to the ground and rise again. The tail then kept on rising causing the idling propeller to strike the ground and the engine to stop. The aircraft slid on the lower engine cowling for a short distance until the propeller nose cone caught the ground and the aircraft stood vertically on its nose. After a brief pause in the vertical attitude, the tail of the aircraft continued forward until the aircraft was completely inverted. The aircraft came to rest, inverted and facing toward the approach end of the runway, at a point approximately fifty feet beyond its normal holding position (see photo 1).

Photo 1: Final Resting Place

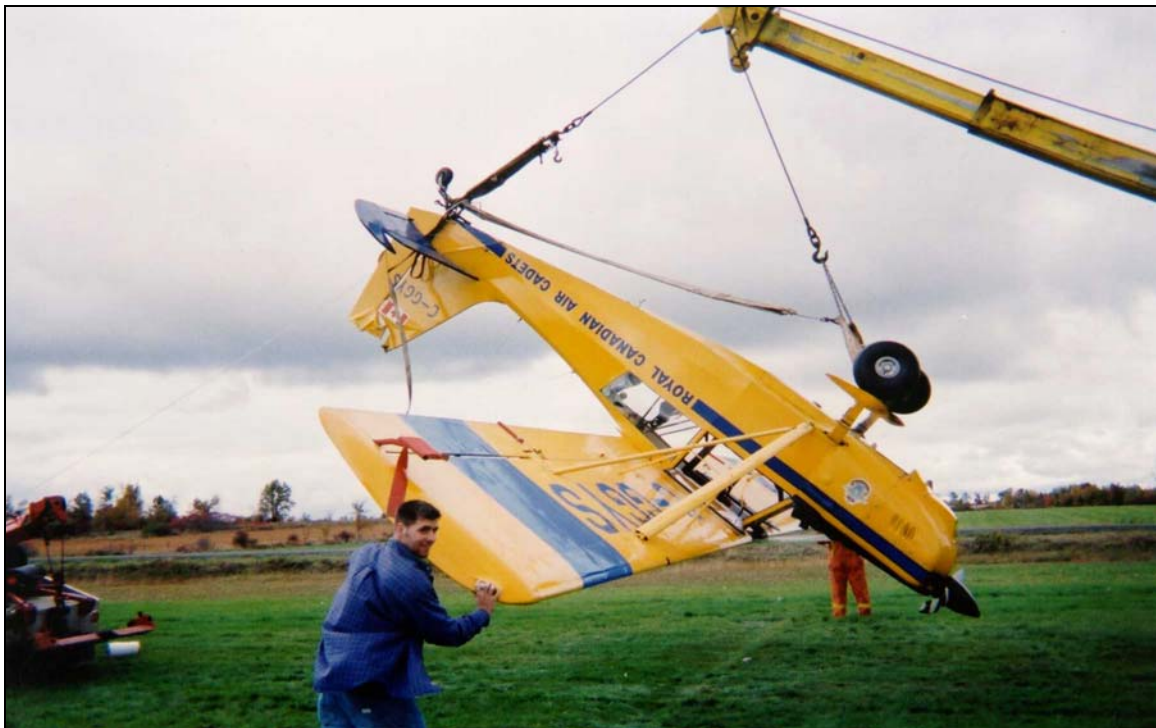
The aircraft was returned to its upright position by a local crane operator who has experience with this operation. He used a boom crane to elevate the aircraft and a tow truck to rotate the nose of the aircraft forward (see photo 2). This operation was successful and did not cause any further damage to the aircraft.

Photo 2: Aircraft in sling

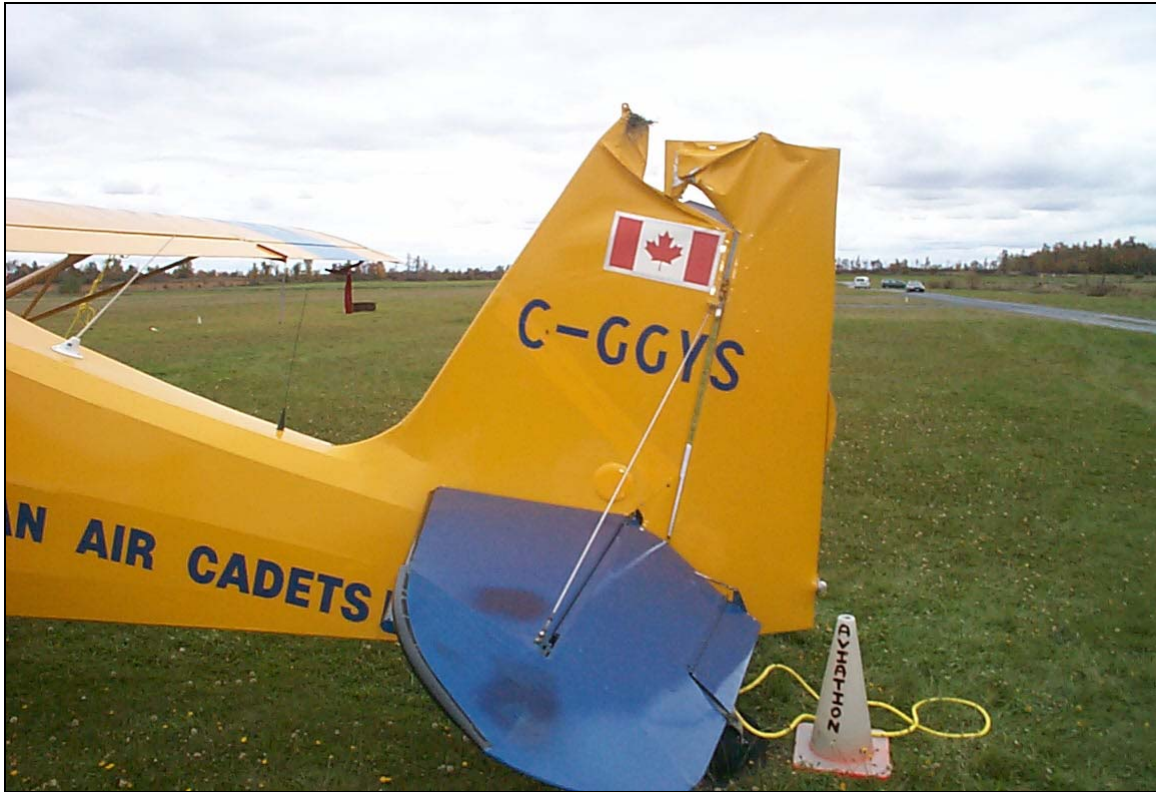
The aircraft received "B" Category damage. The propeller was slightly bent at the tips. The engine experienced a sudden stoppage and, as per the manufacturer's recommendation, was sent to an overhaul facility. The top of the vertical stabiliser contacted the ground and suffered considerable skin and structural damage (see photo 3). The weight of the inverted aircraft on the wing caused some buckling of the wing structure at the wing roots and damage to the flap mechanism (see photo 4). The lower part of the engine cowling was cracked at the lower right corner of the air filter holder and a large piece of "Gelcoat" was delaminated on the left front. The windshield, right window and skylight were cracked (see photo 5). The wing struts were also slightly bowed and one of the

Photo 3: Tail damage

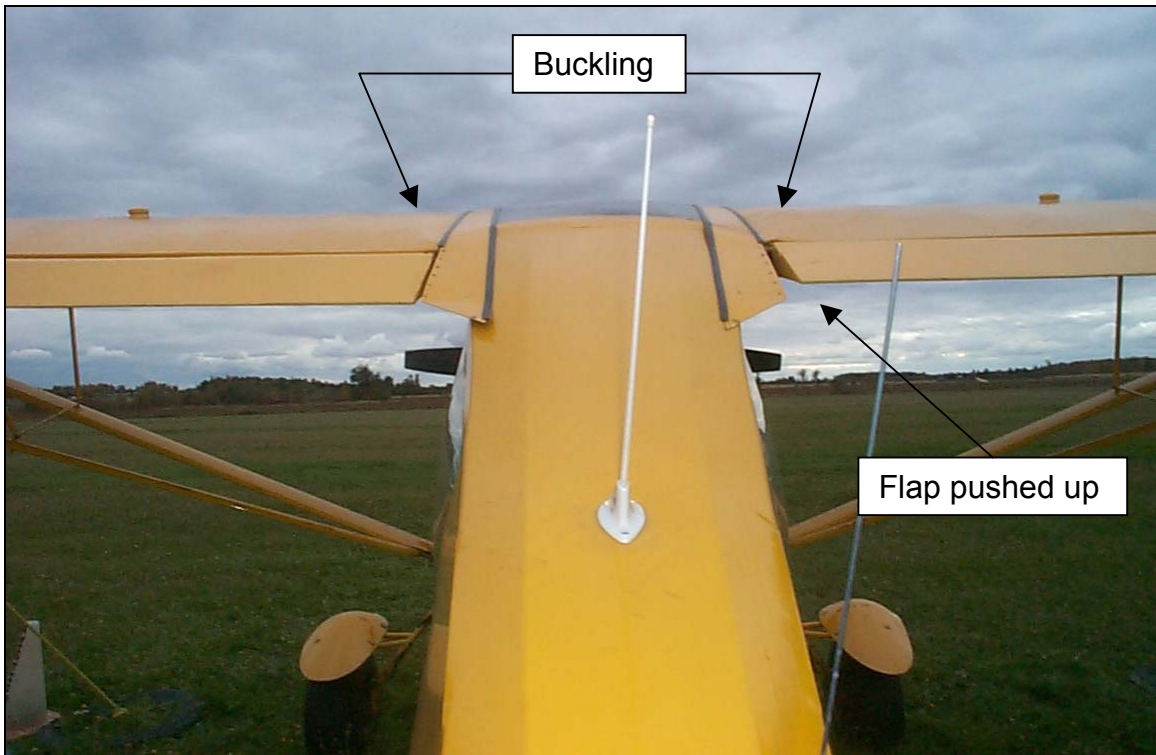
Photo 4: Wing root damage

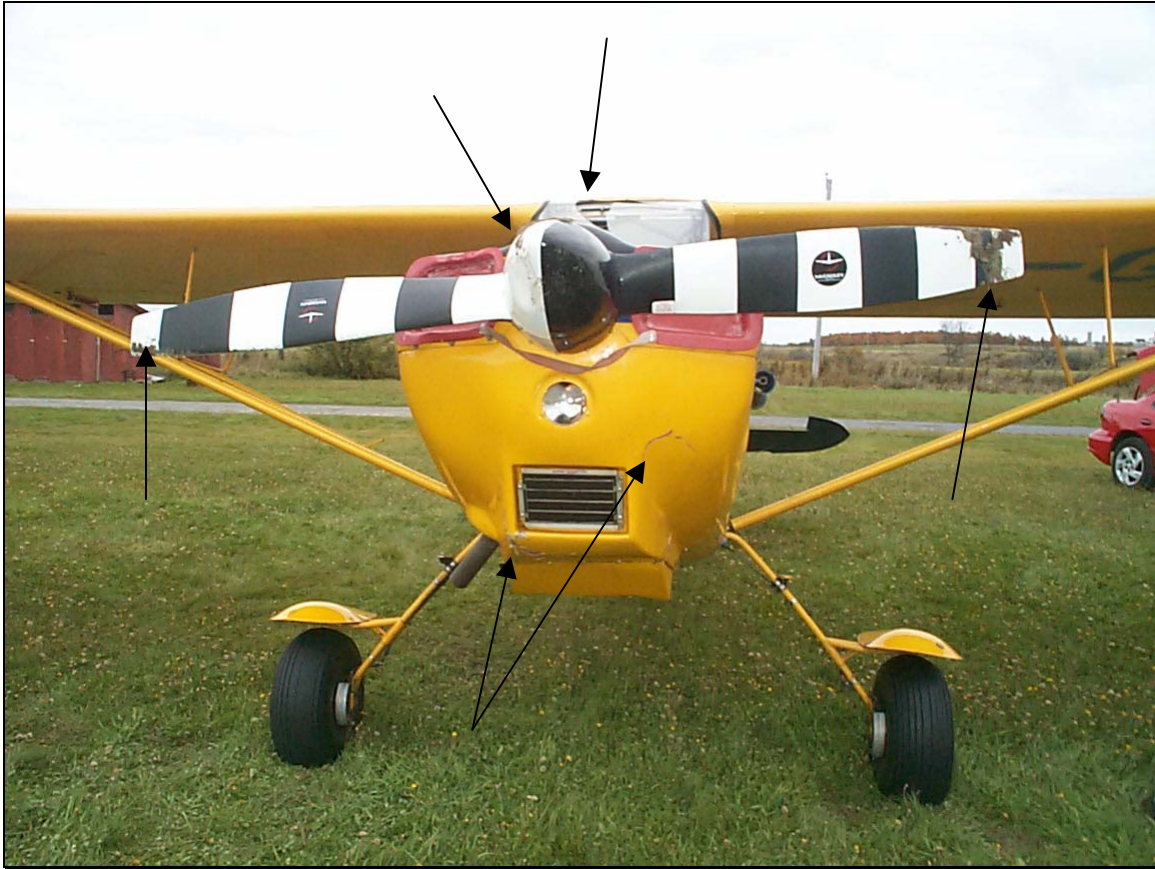
Photo 5: Nose damage

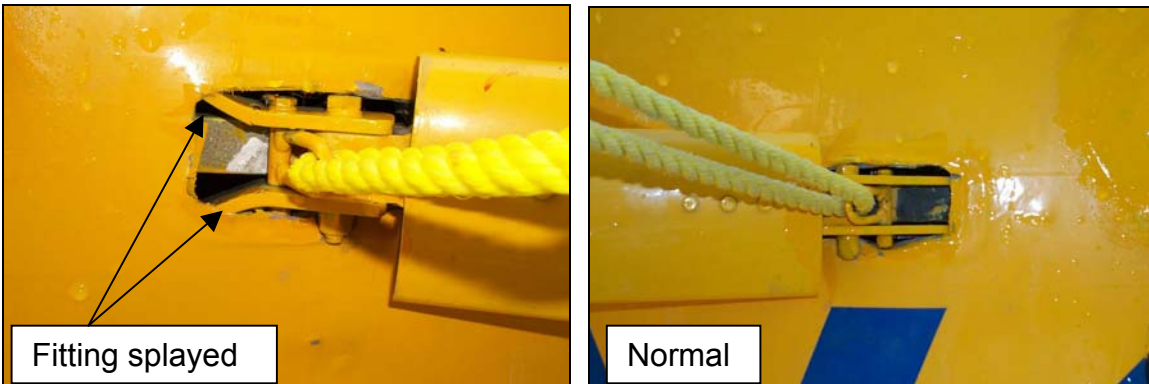
attachment points was splayed (see photo 6). The diagonal tube crossing the skylight was bent downwards.

Photo 6: Wing strut damage
